DEPARTMENT OF TRANSPORT

Investigation into the Clapham Junction Railway Accident

Anthony Hidden QC

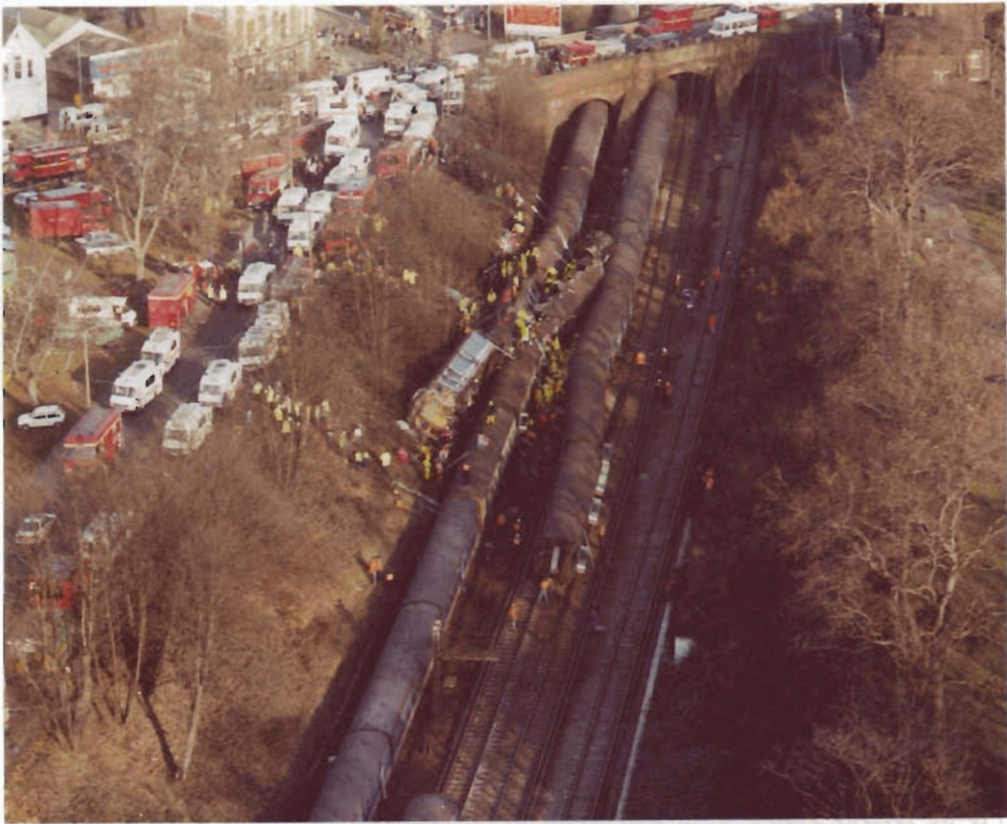
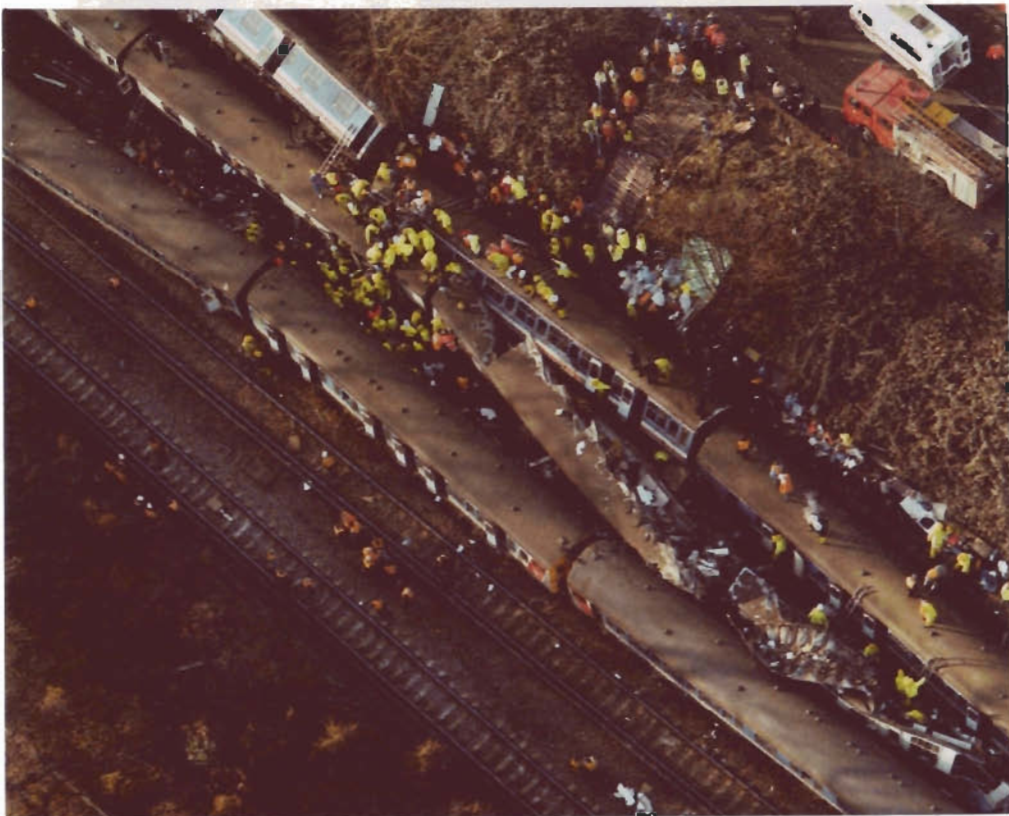
5.16 There were problems in getting access to the site. There were tall metal railings, a steep wooded embankment followed by a 10 foot high concrete wall to be negotiated before it was possible to get down to the track. The first three carriages of the Poole train had suffered enormous damage. The first carriage had totally collapsed. The second carriage, the buffet car, had been devastated more particularly upon its left near-side. The close proximity of all three trains on the track made for great difficulty. So did the position of the last coach of the Basingstoke train which had been thrown by the impact above the concrete wall and onto the embankment. It was lying on its left near-side at an extreme angle, with its offside doors open to the sky. Figures 1 and 2 show the difficulties the rescuers had to face.

Fig 1. } Aerial views of the accident site.
Fig 2. }

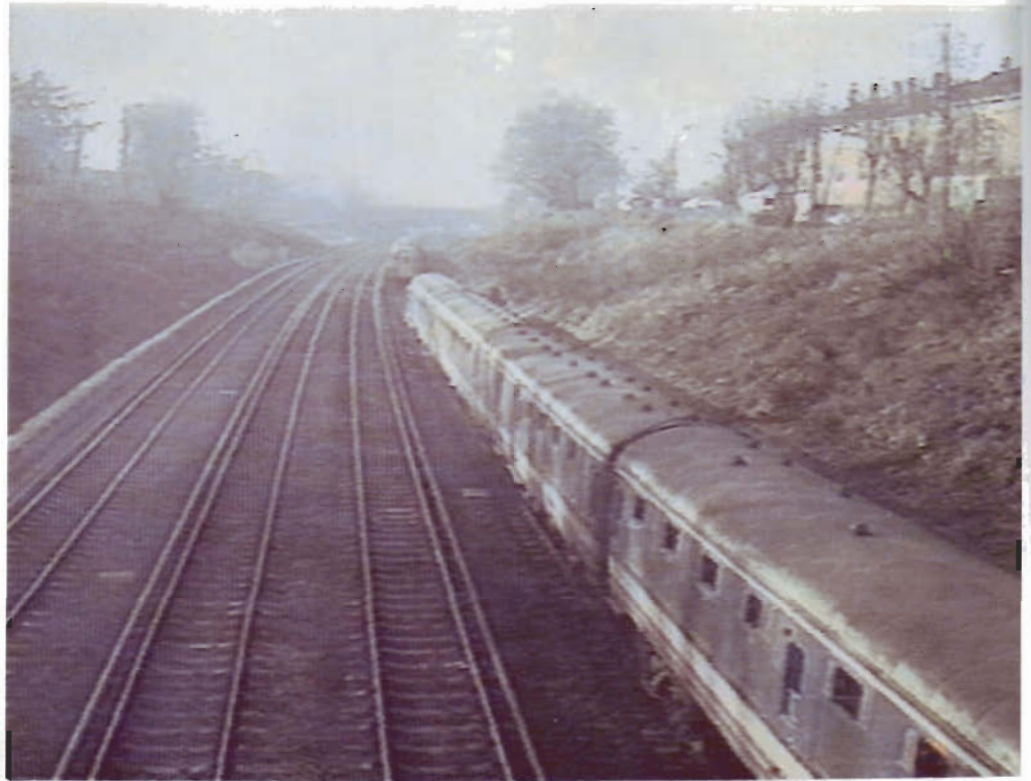
Fig 3. Driver Pike's train stationary approximately 60 yards from the rear of the Poole train.

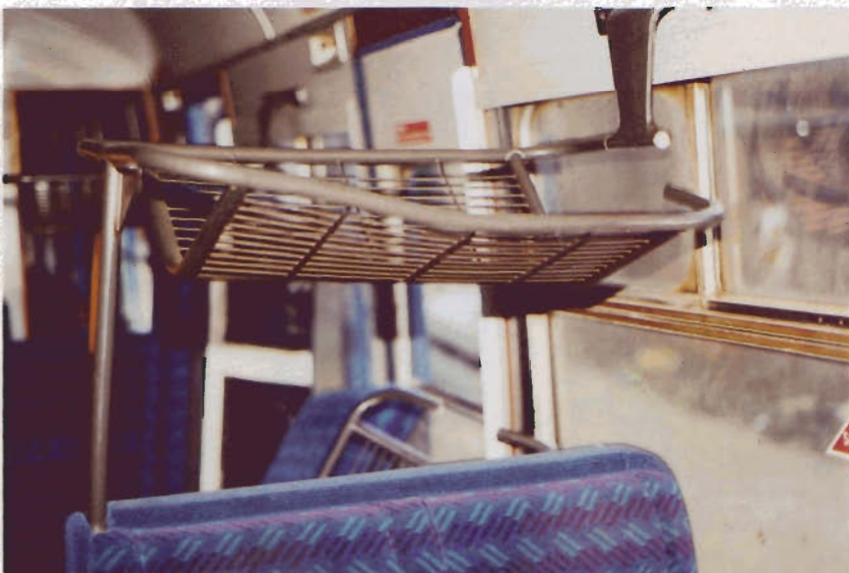
Fig 9. An interior view of a carriage of the Basingstoke train, showing damaged transverse luggage racks.

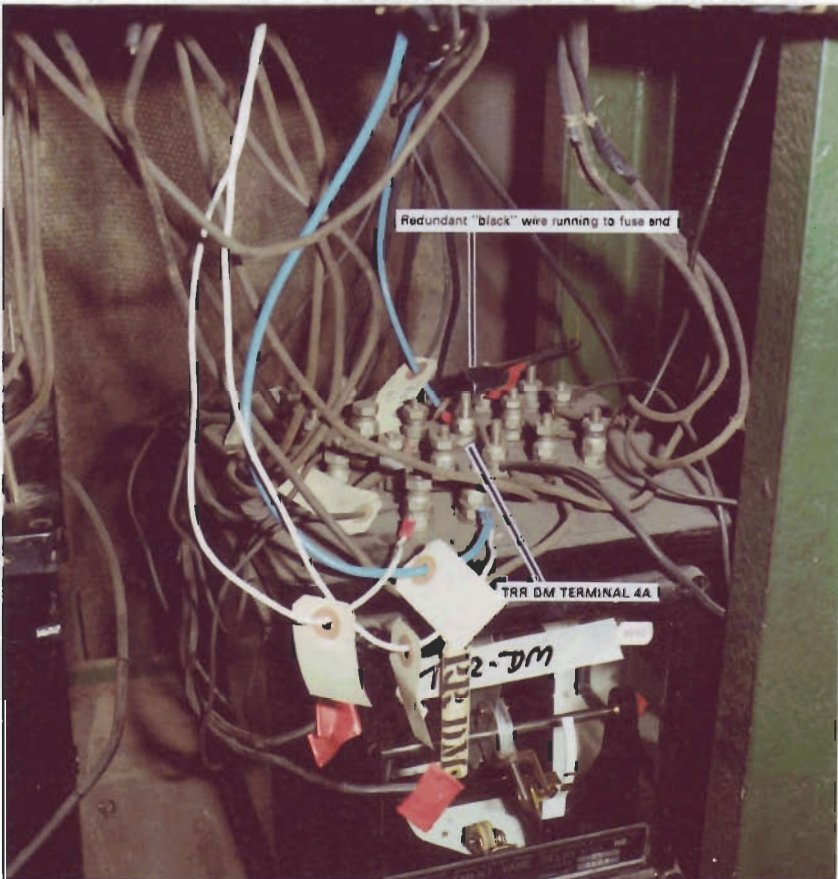
Fig 13. Relay TRR DM taken on 12 December at approximately 14.00 hours.

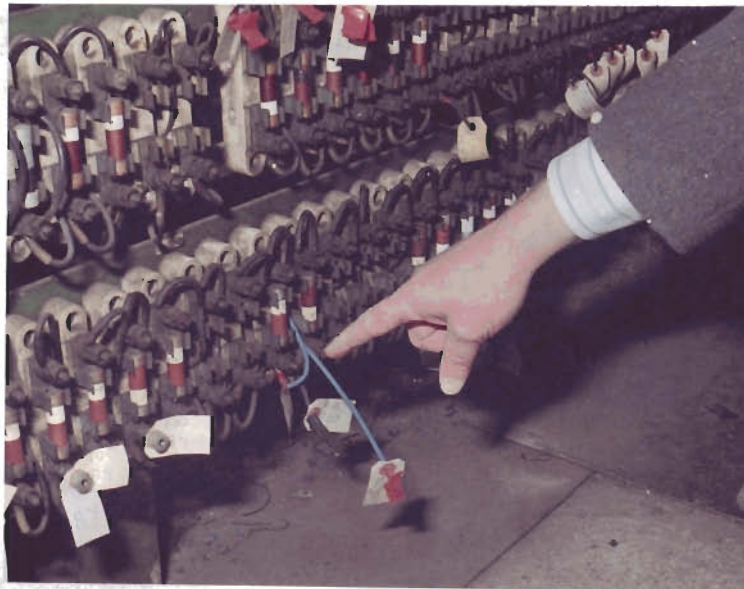
Fig 14. Fuse racks. Row 12-f107, taken on 13 December.

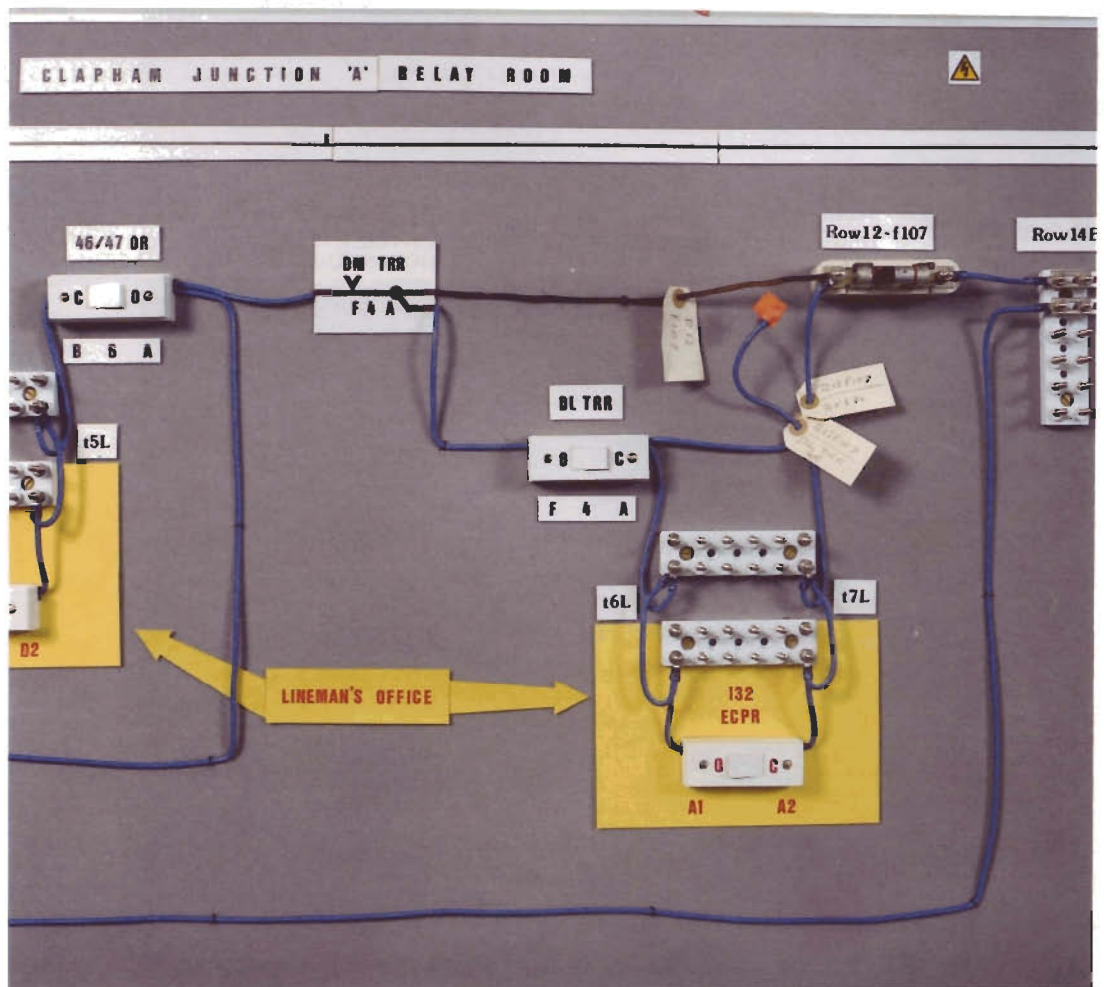
Fig 15. Extract from the working model demonstrating jobs 104 and 201 and the wiring errors made. The black wire along the top of the diagram connected at DM TRR and Row 12-f107 should have been disconnected at both ends but was wrongly left connected at the fuse end at Row 12-f107. Although disconnected at the relay end the wire was left loose and made metal-to-metal contact at DM TRR allowing a false feed of current to by-pass DL TRR. Hence the occupation of track circuit DL by a train had no effect on signal WF 138 and it did not turn back to red as it should have done.

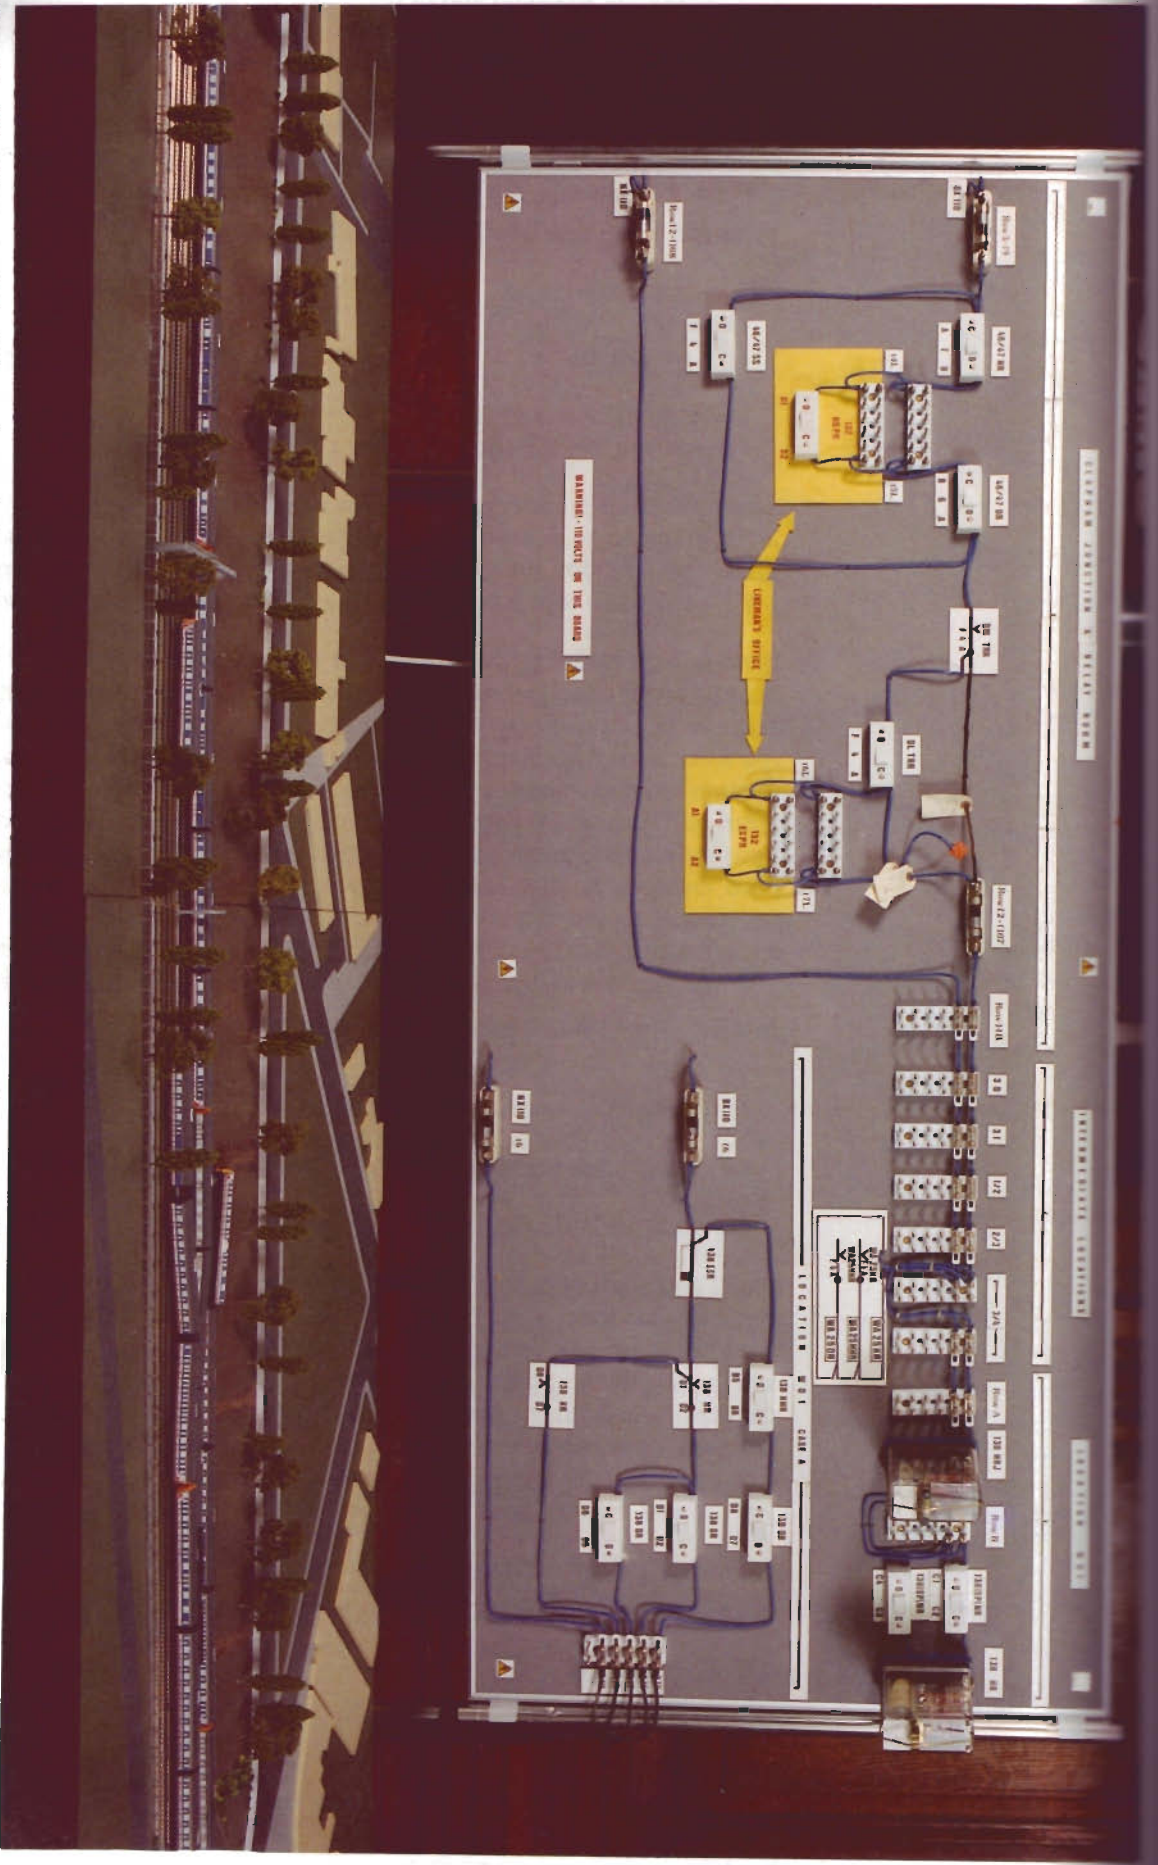
Fig 16. Working model of the relevant signalling circuits, showing wiring errors; and topographical model of the crash site.

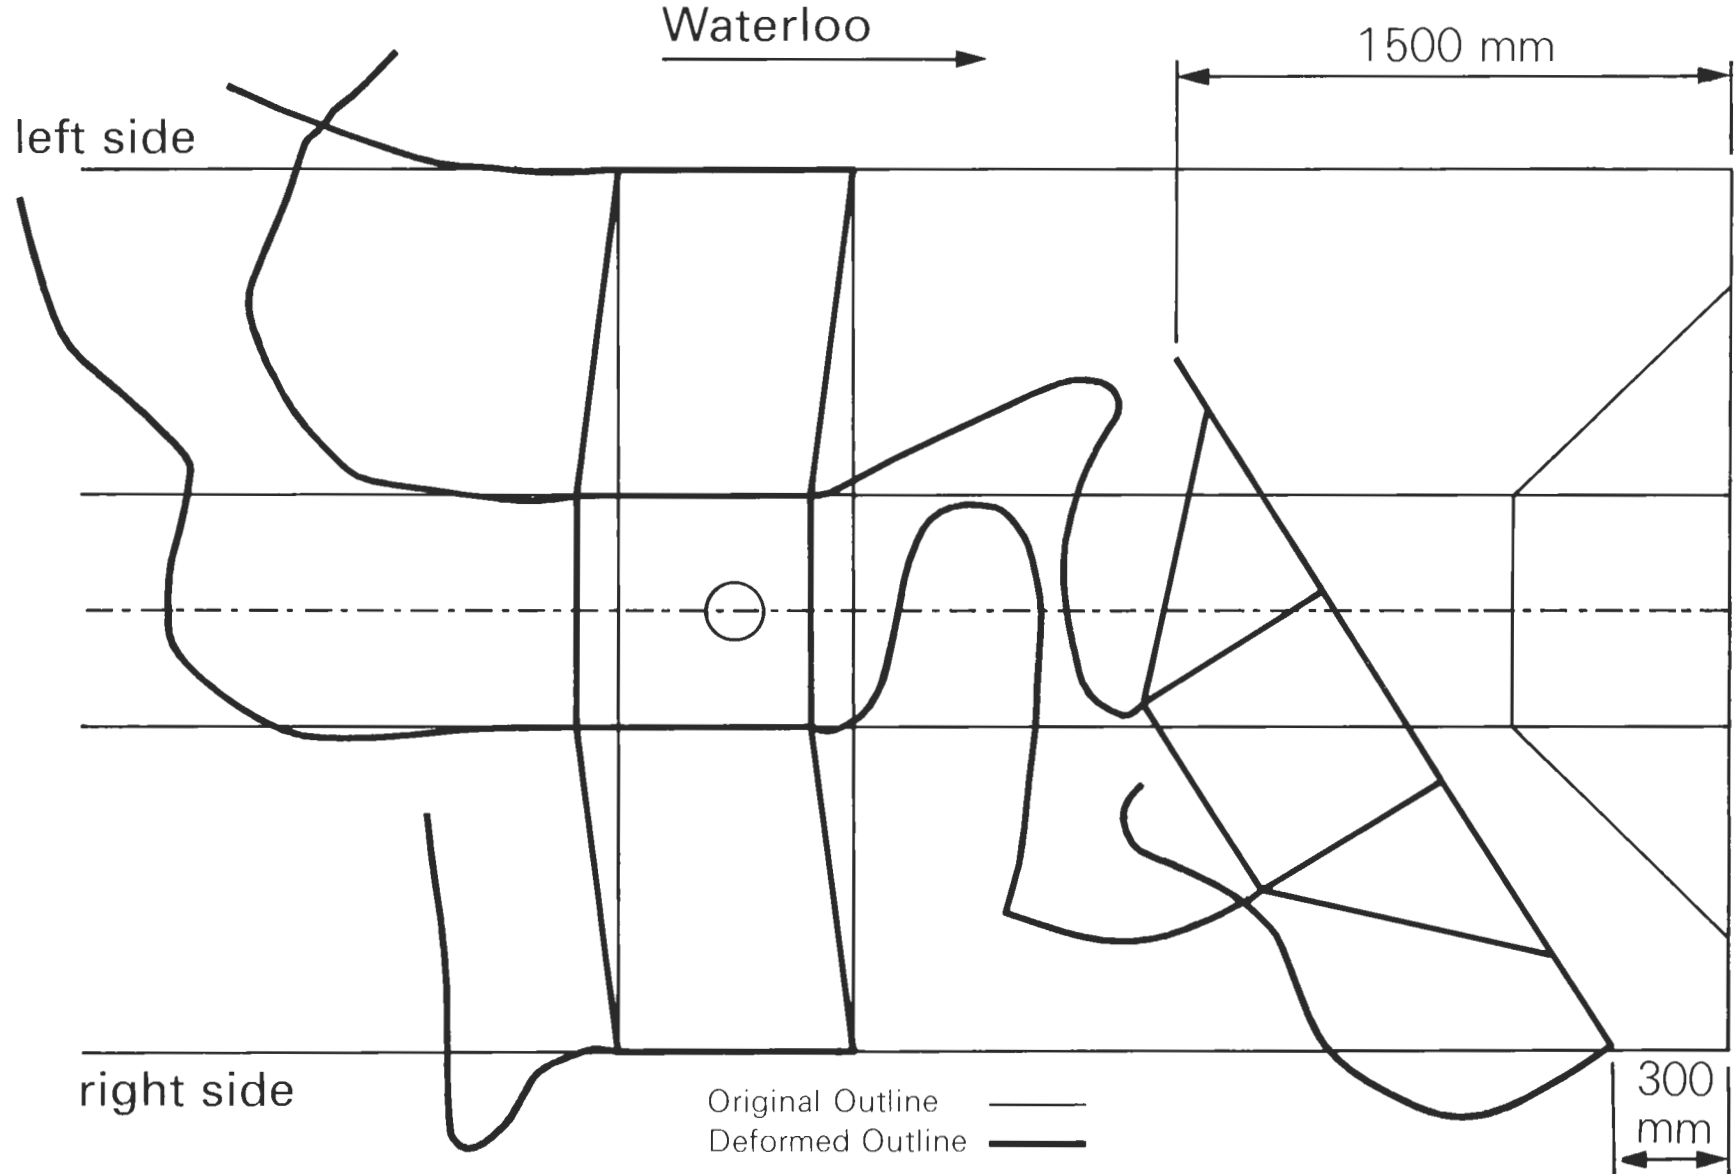
PLAN VIEW OF PERMANENT DEFORMATION OF
DMS 62146 (Leading End)

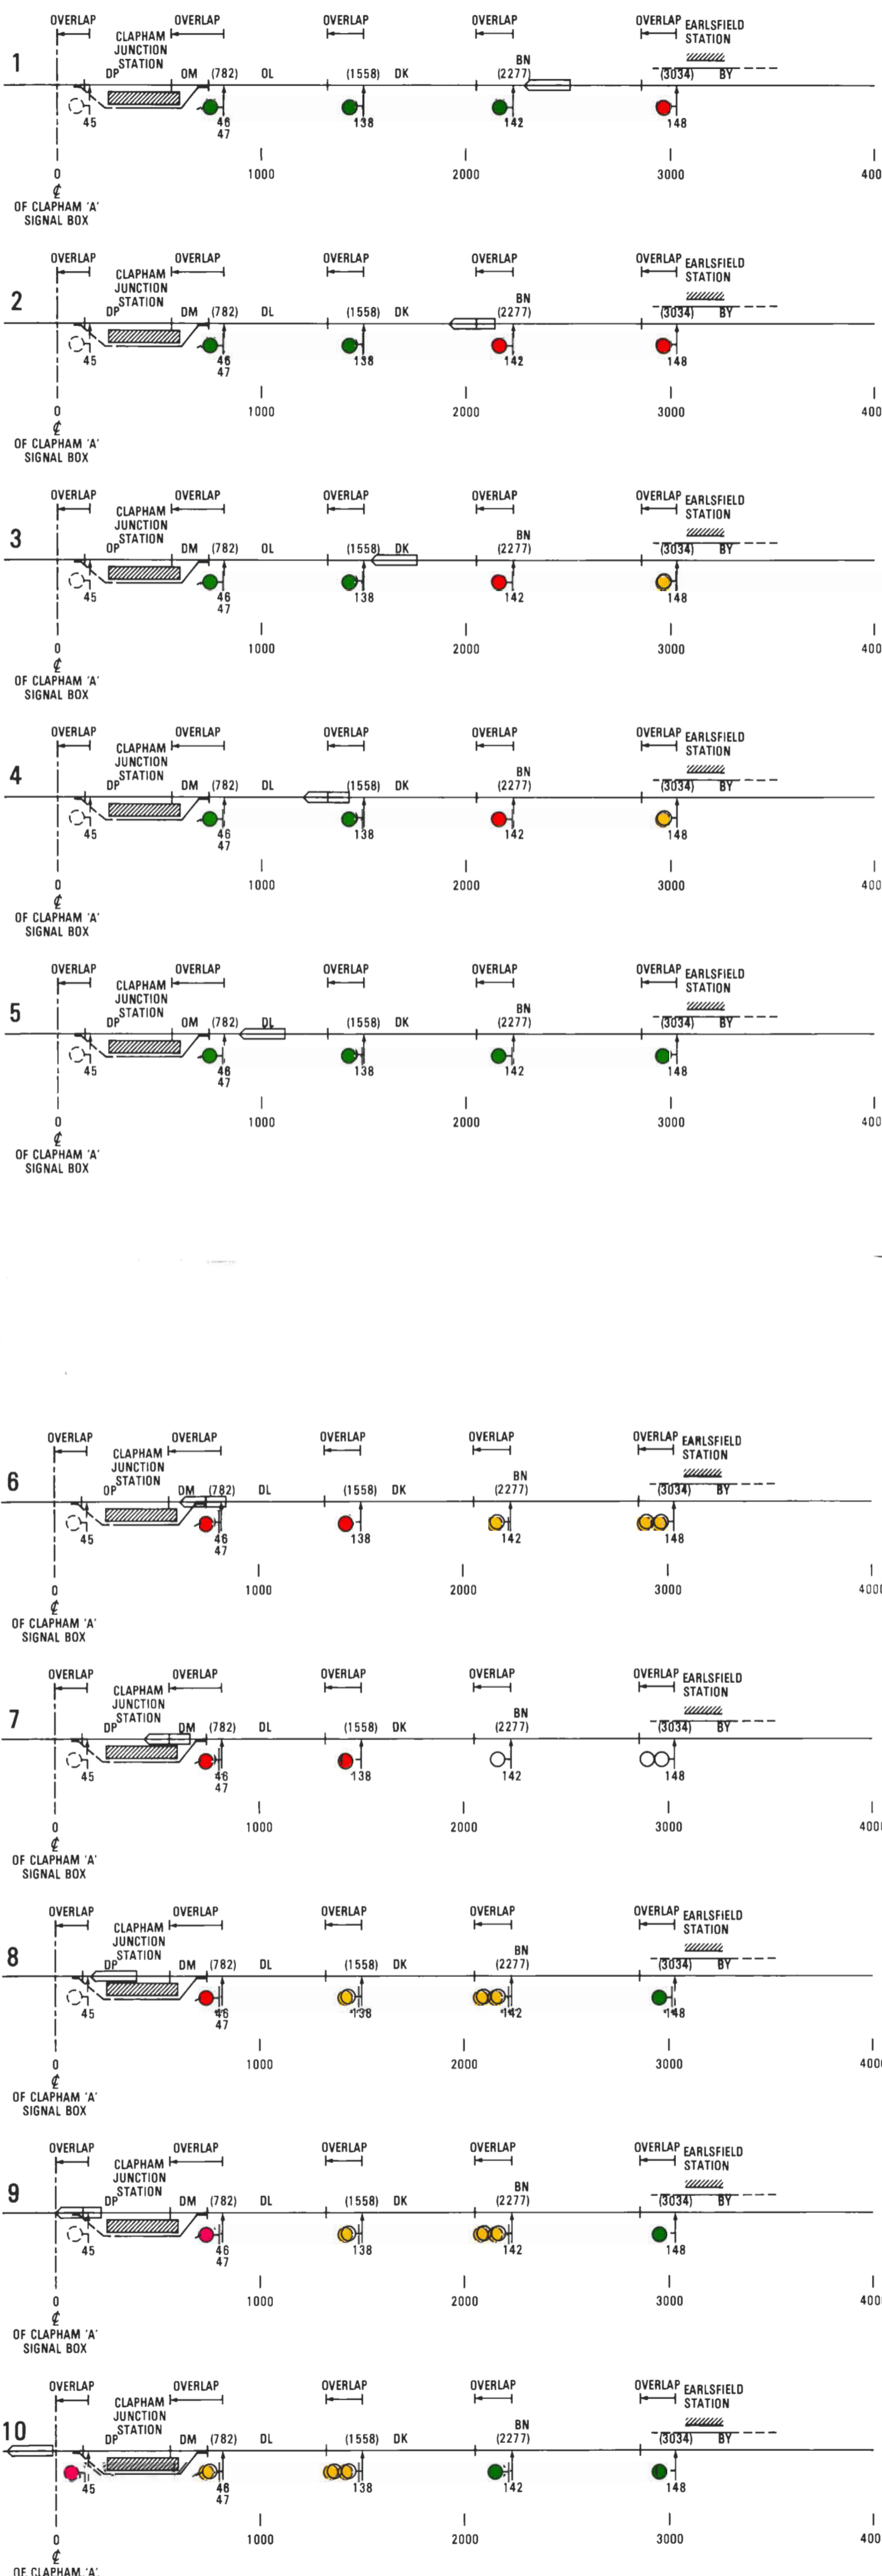
(B) ASPECT SEQUENCE OF SIGNALS WITH ONE TRAIN PASSING SHOWING EFFECT OF WIRING ERROR

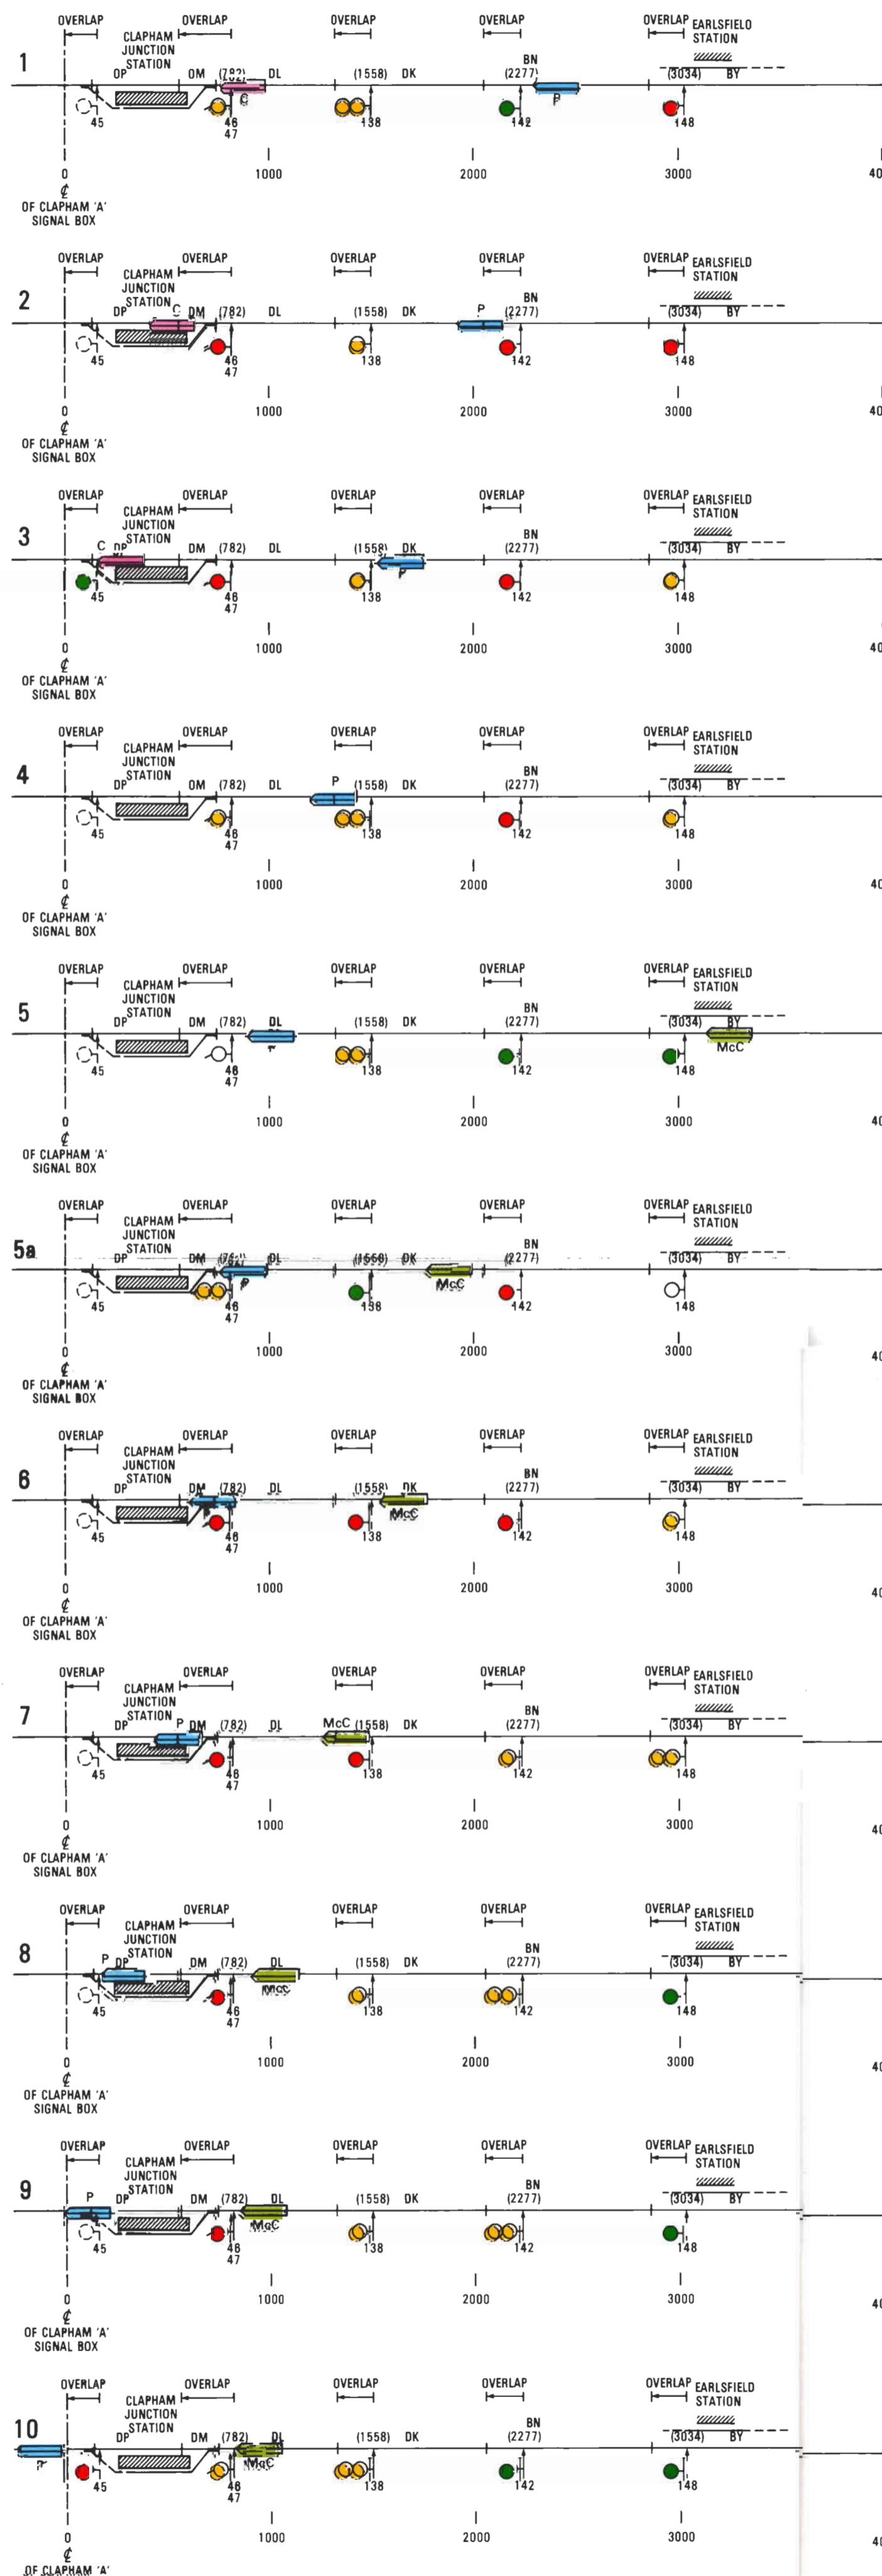
(C) ASPECT SEQUENCE OF SIGNALS WITH SEVERAL TRAINS PASSING ON MORNING OF 12 DECEMBER SHOWING EFFECT OF WIRING ERROR
